# Allied-Axis

THE PHOTO JOURNAL OF THE SECOND WORLD WAR

## Karl-Gerät 040 at the front

Panzerjäger I • SdKfz. 10 1-ton halftrack  
U.S. M2 Treadway Bridge • PzKpfw. IV Ausf. A  
Type 97 Japanese medium tank

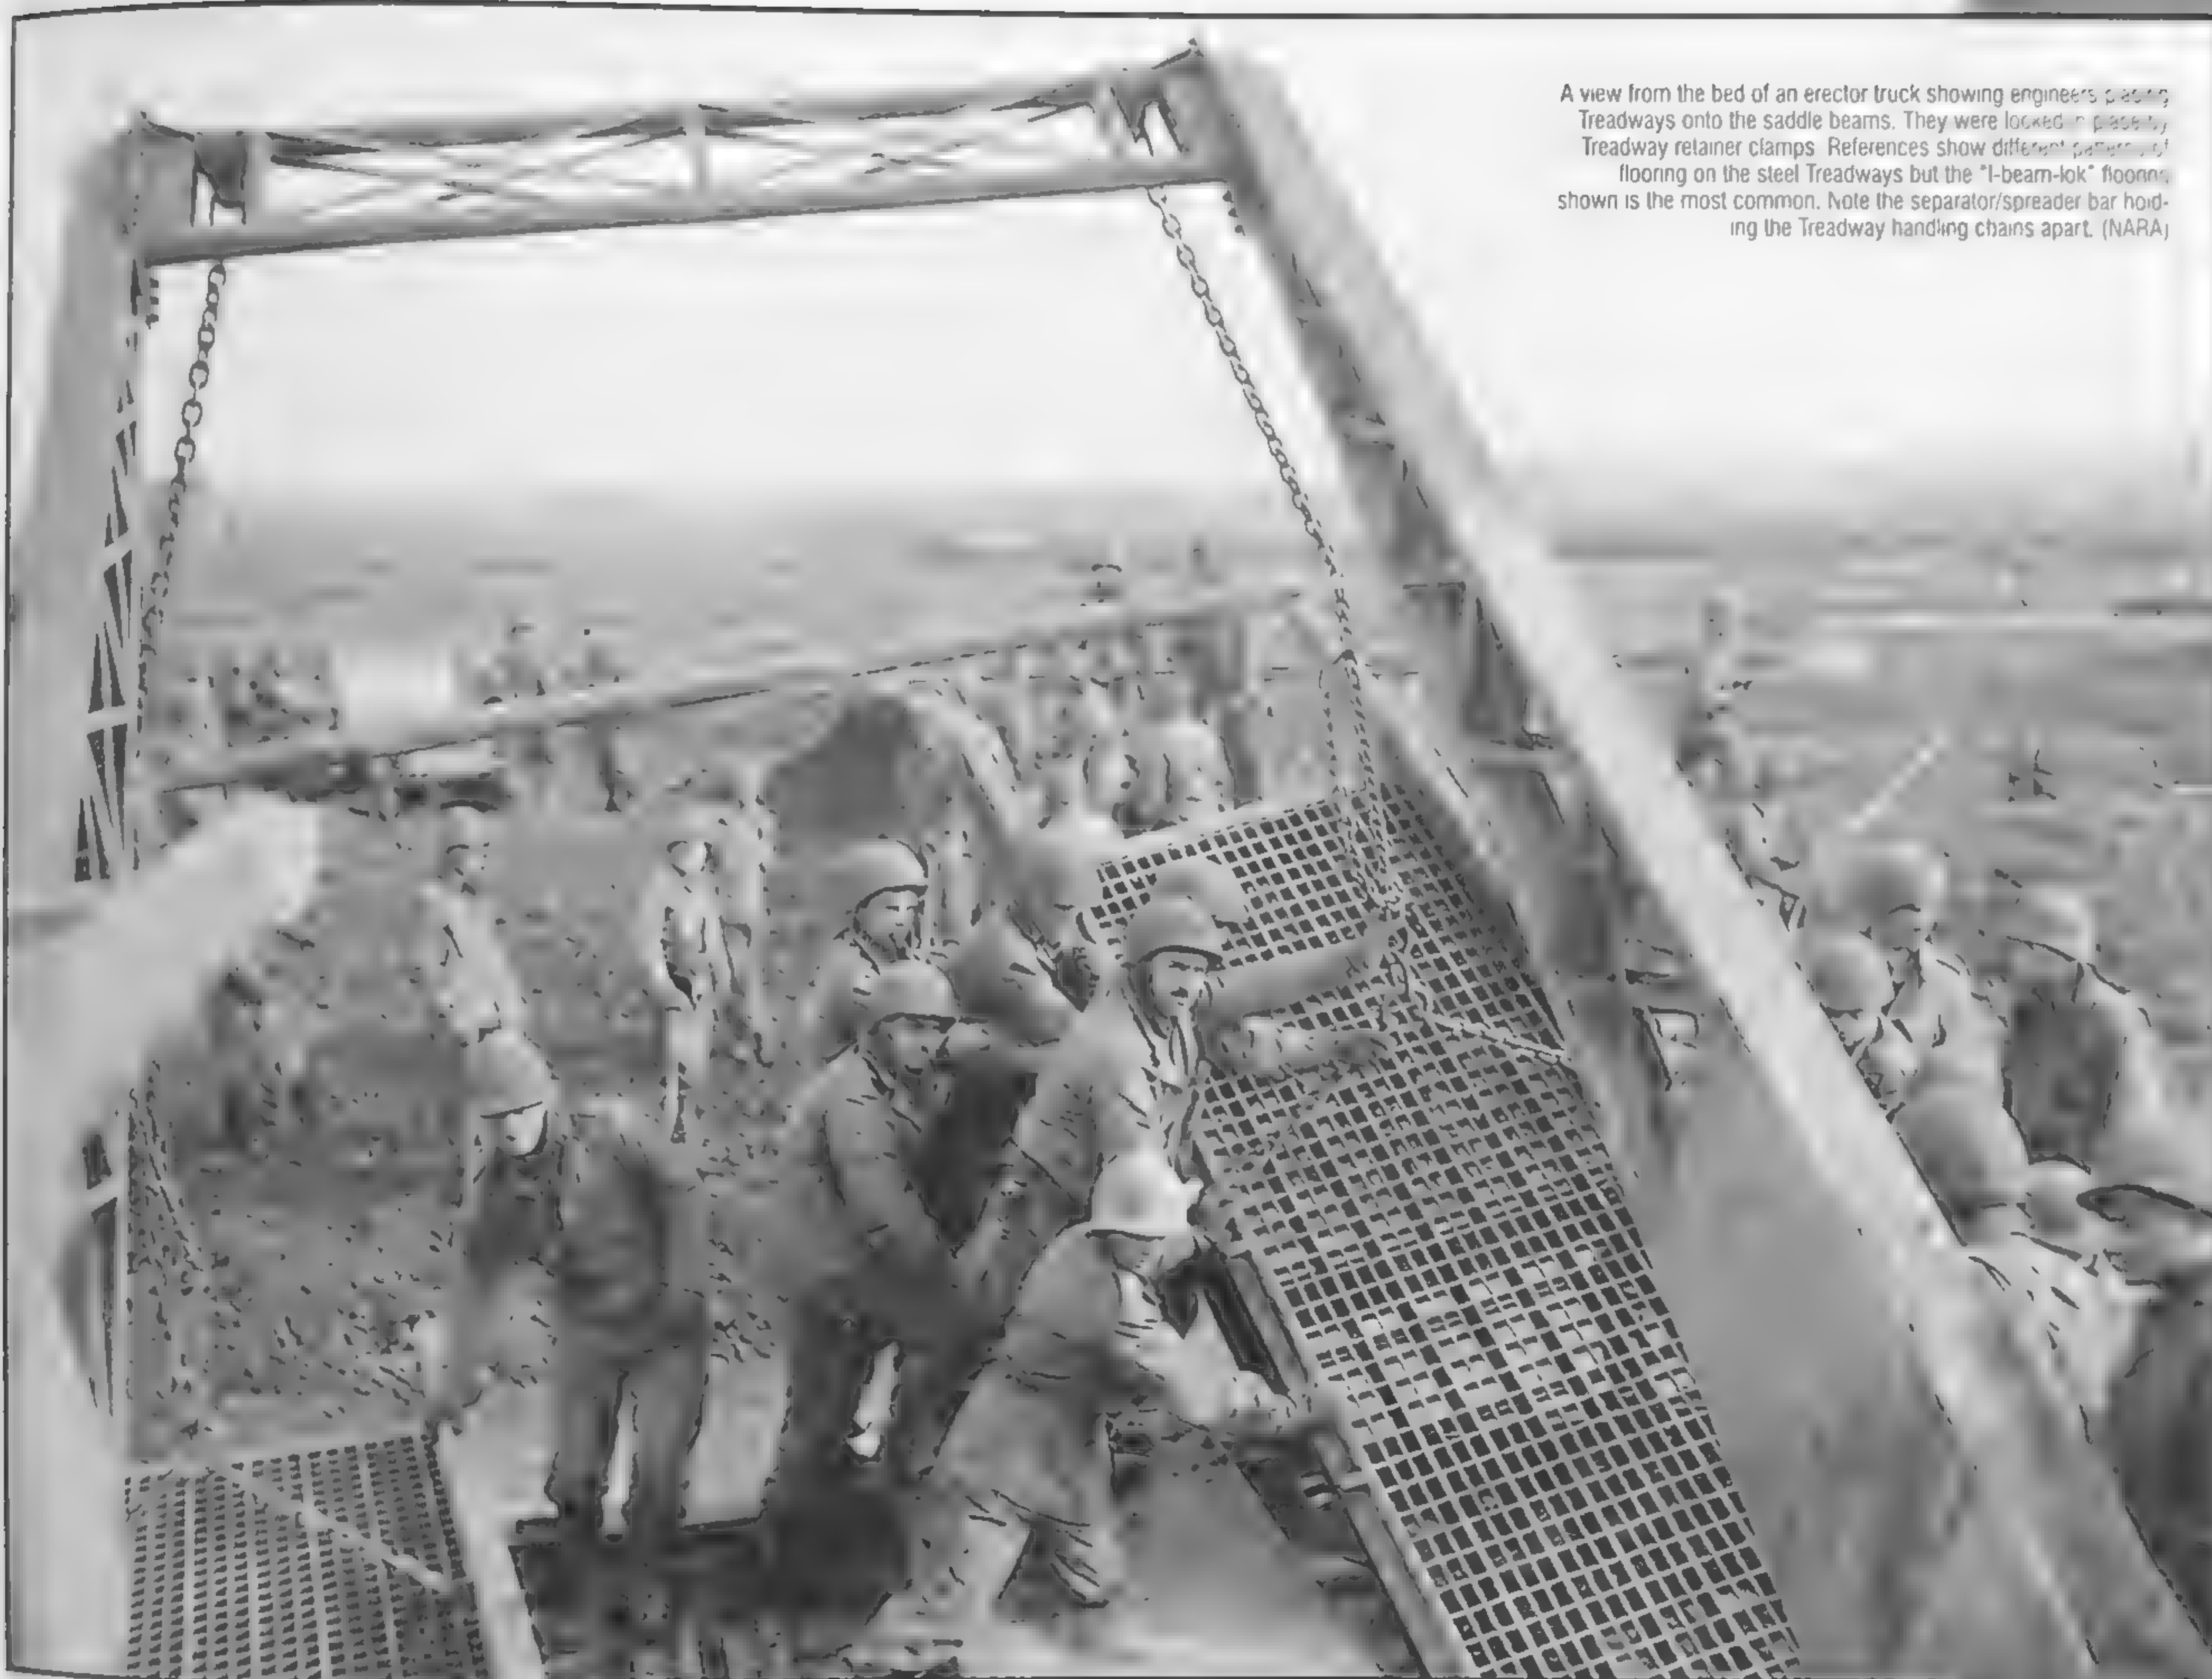
A view from the bed of an erector truck showing engineers passing Treadways onto the saddle beams. They were locked in place by Treadway retainer clamps. References show different patterns of flooring on the steel Treadways but the "I-beam-lok" flooring shown is the most common. Note the separator/spreader bar holding the Treadway handling chains apart. (NARA)

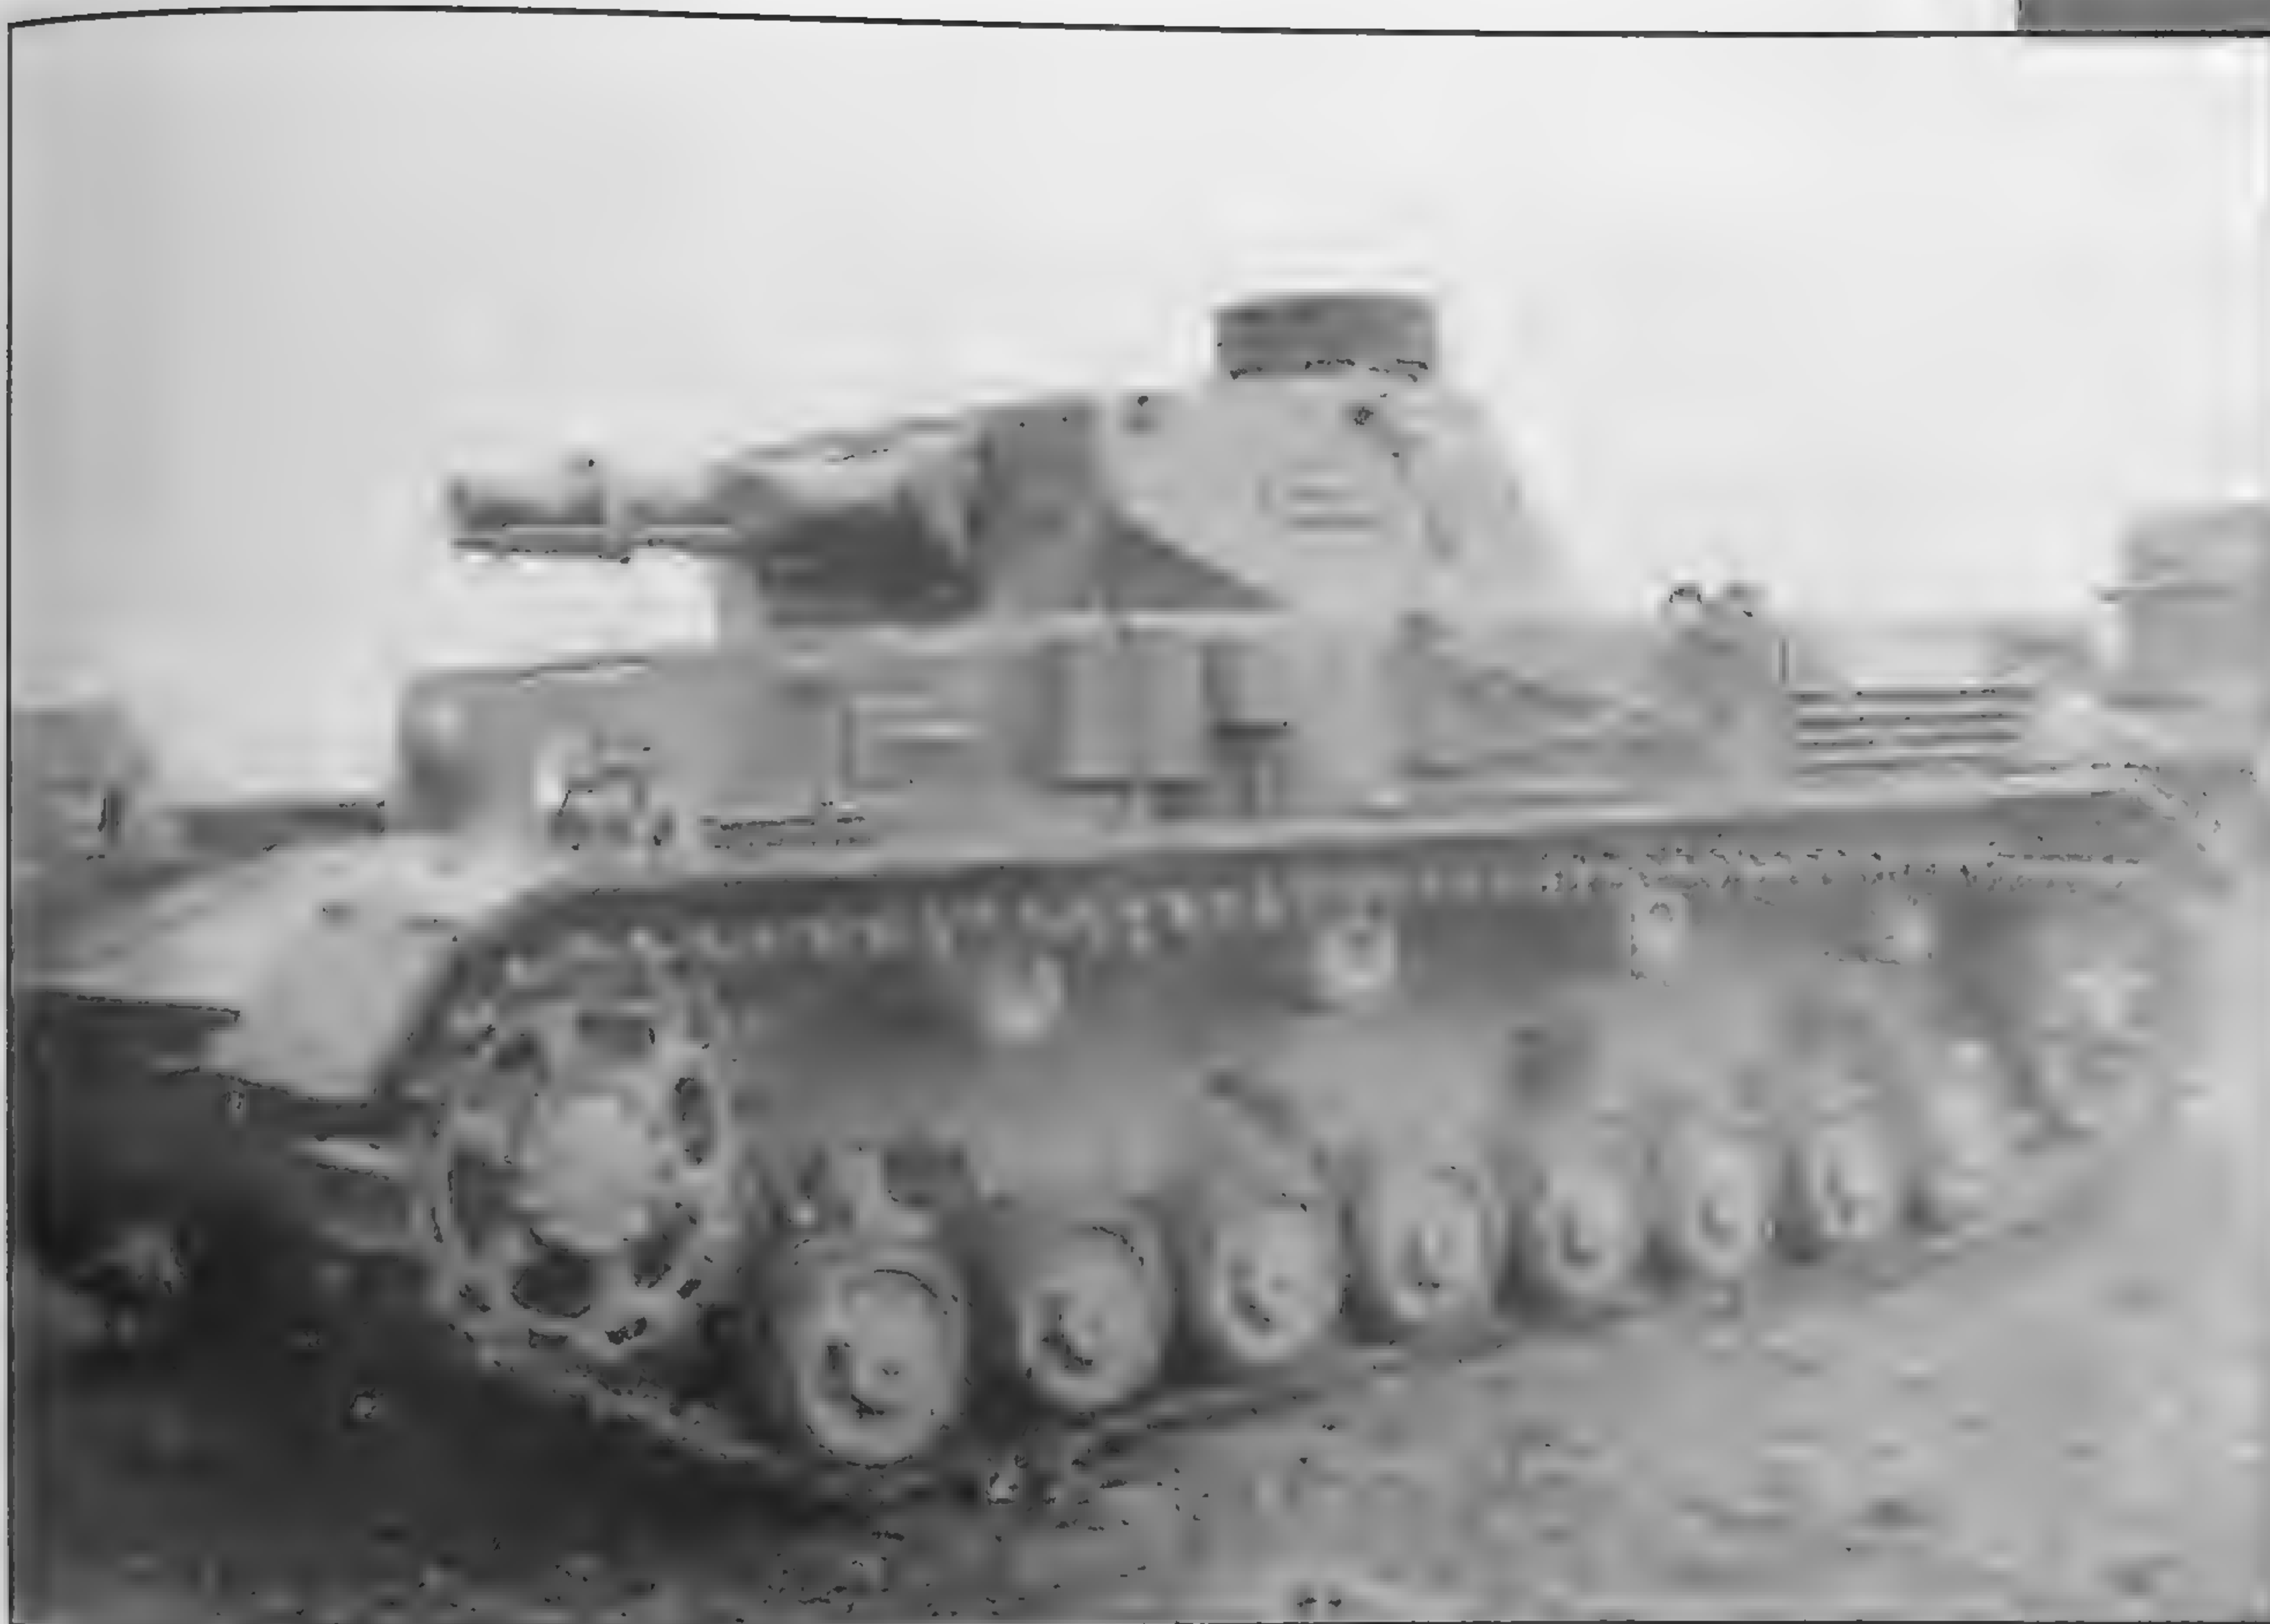
This initial version of the Pz Kpfw IV had 14.5mm thick plates on all vertical surfaces, which provided complete protection against steel-cored armor-piercing bullets fired by machineguns and rifles. This was sufficient to regain mobility that had been lost due to massed machine gun fire in World War I. Germany learned that the French were working on the development of a 25mm automatic cannon. They

were concerned that Panzers only protected against machine gun fire would be mowed down by these automatic weapons just like the cavalry had been dominated in World War I. The armor thickness on the next model of the Pz Kpfw IV, the Ausf. B, was increased to 30mm thickness. (BA)

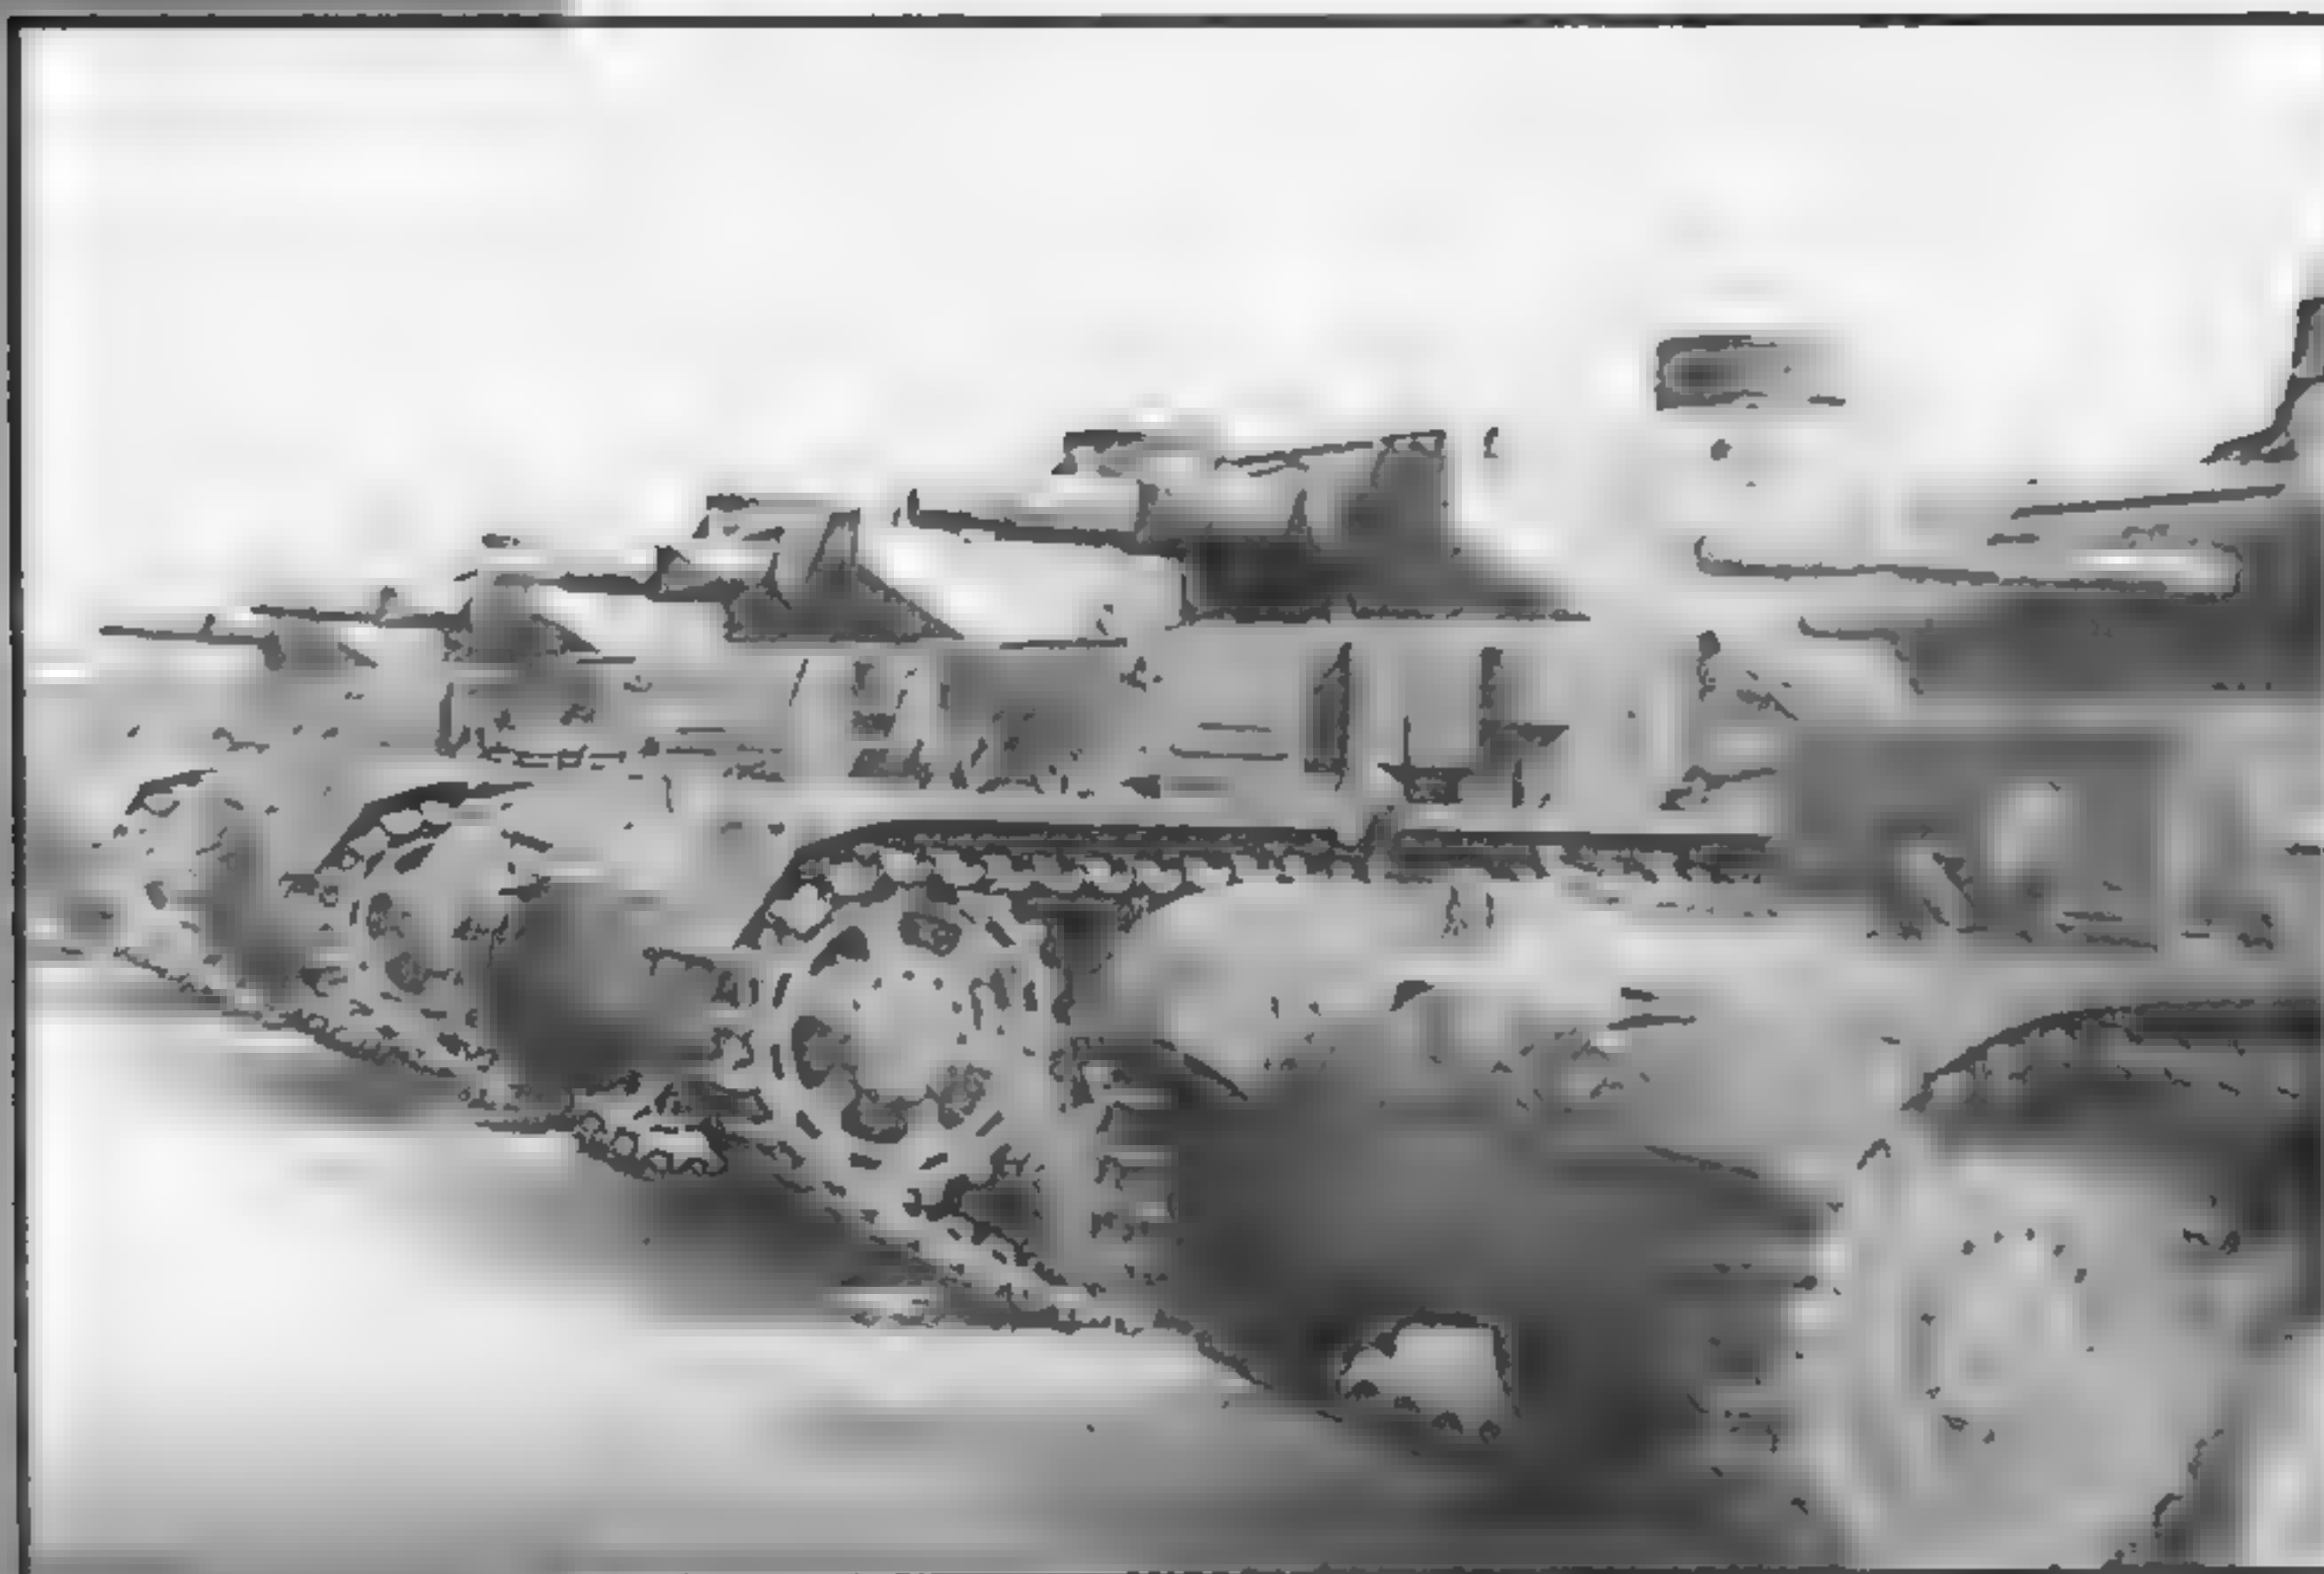
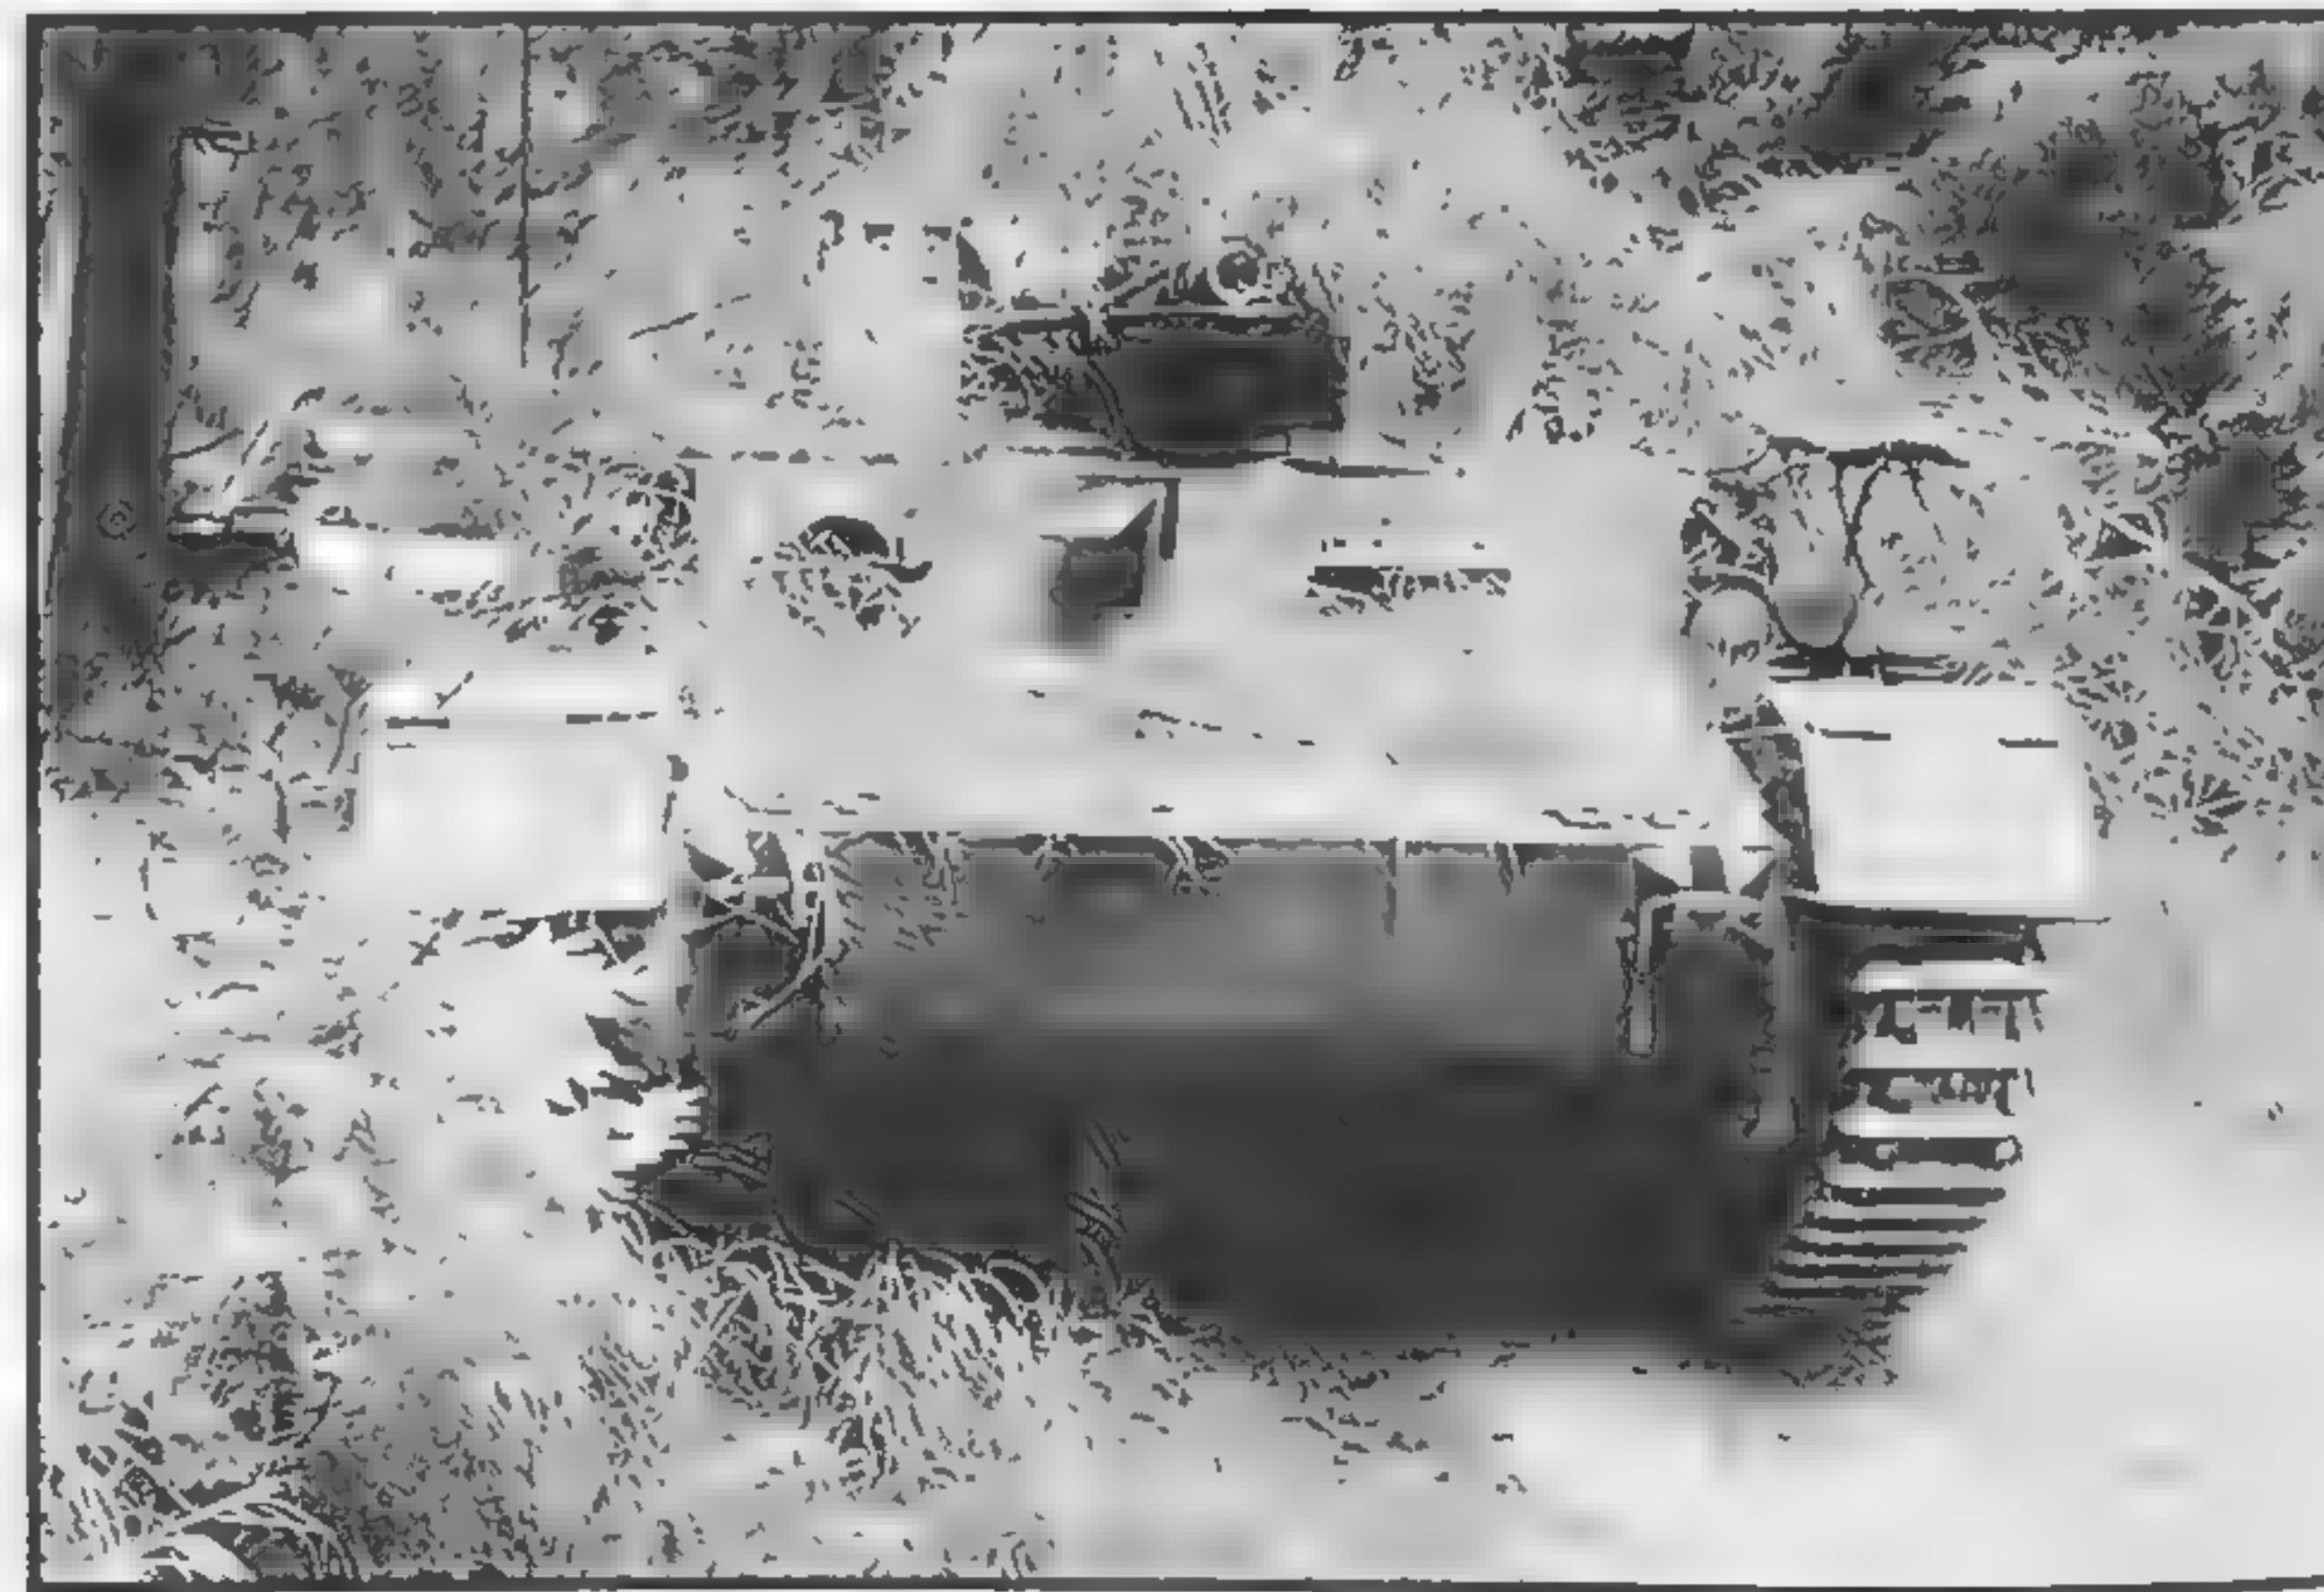
**Top left:** This photo of an Ausf. A was taken at a training ground. It shows no markings other than the black rhomboid numbering plate. The vehicle number 824 is not painted in white, but possibly in the vehicles base color dark gray or in yellow. (Photo private) **Top right:** The same vehicle from the left hand side. No Notek light is visible, so this photo was taken before 1940. (Photo private) **Above left:**

Here an Ausf. A leads a row of Ausf. Bs. Initially, up to three Pz Kpfw. IV were issued to each medium company, with more added as production increased. (Photo van Berkel) **Above right:** Carefully camouflaged with foliage, this Ausf. A is hidden in a forest. The curved front plate is visible, the vision and machine pistol port to the right of the driver's visor is opened for better ventilation. (Photo van Berkel)
